Appendix A

FIELD MAPPING PHOTOGRAPHS

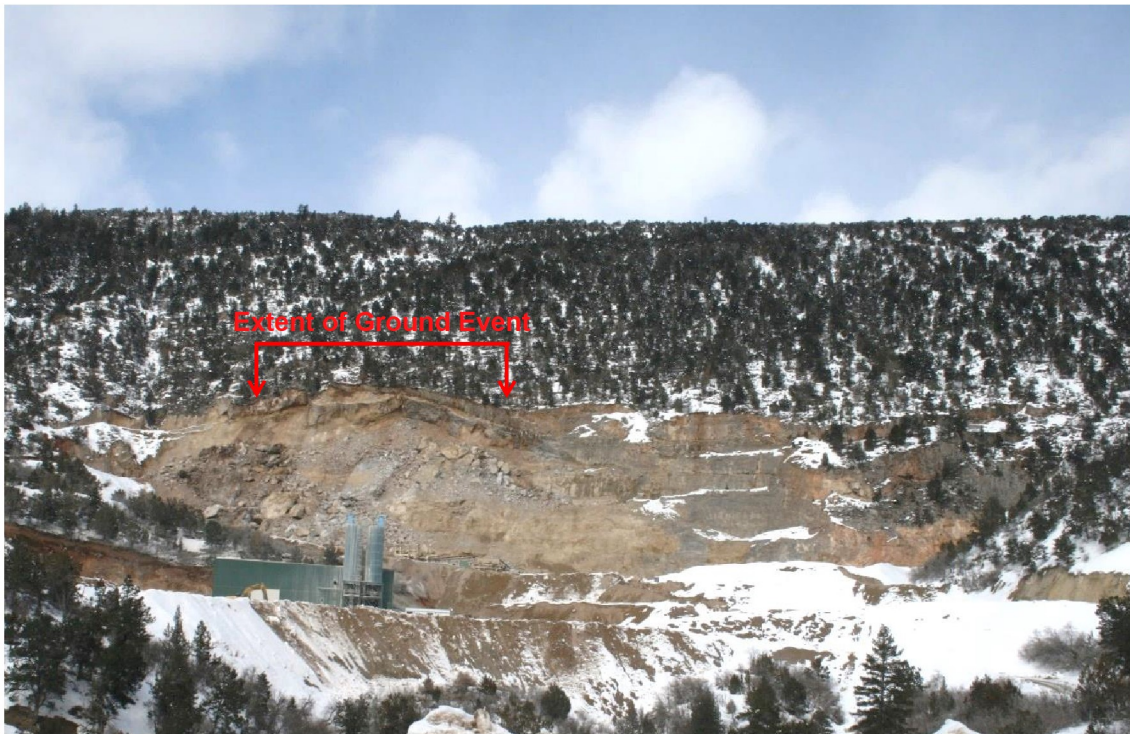
Photo 1: View of the Mid Continent Mine, west face on the left and East Face on the right. The January 2023 headwall ground event can be seen on the left, releasing on a consistent, NE-dipping joint plane. (1/26/23 Photo# 0613)

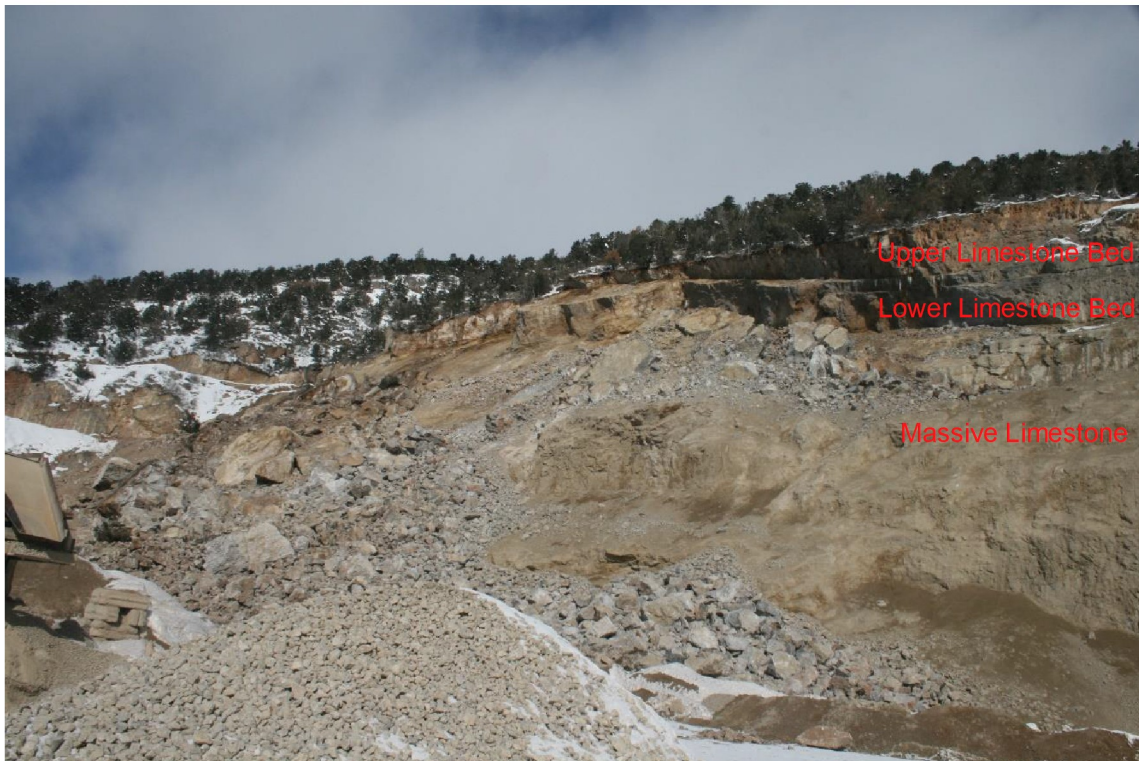
Photo 2: Overview of the January 18, 2023 ground event on the West Face. Rubble path and pile at left. The two upper units of the limestone are visible with bedding acting as the slide plane. (1/26/23 Photo# 0578)

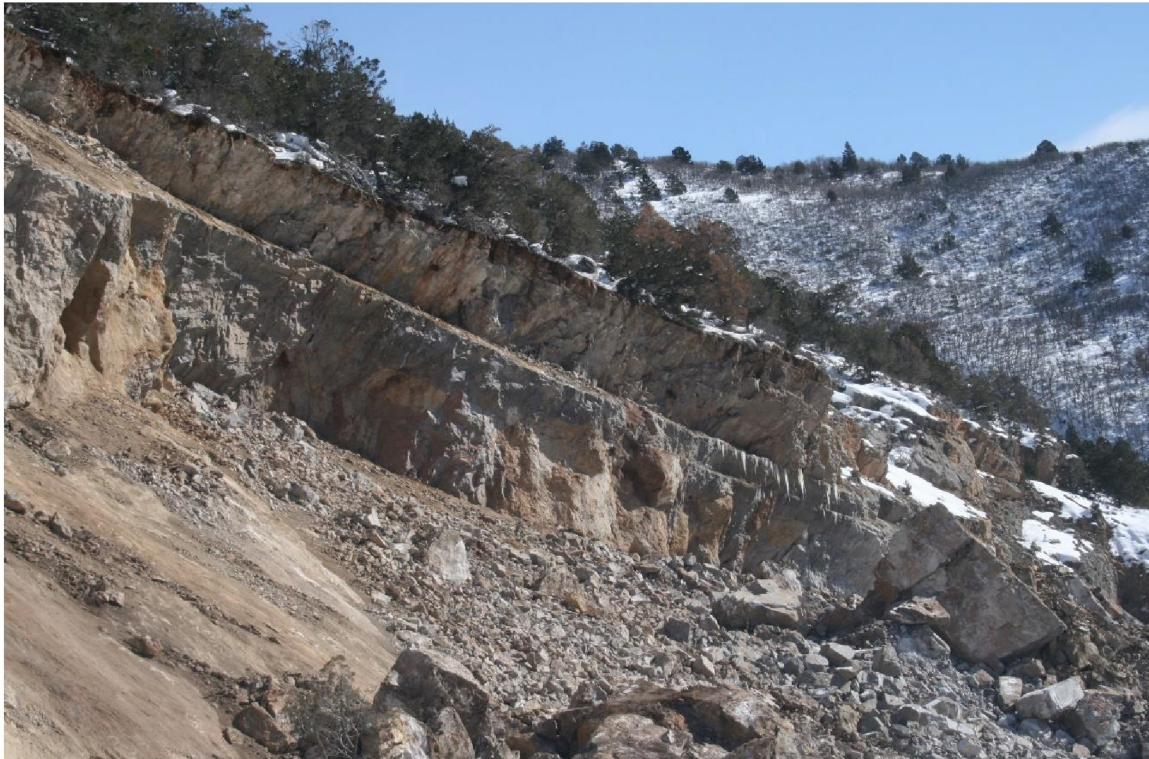
Photo 3: Side view, looking east, of the two upper units of the limestone with bedding acting as the slide plane. (1/26/23 Photo# 0598)

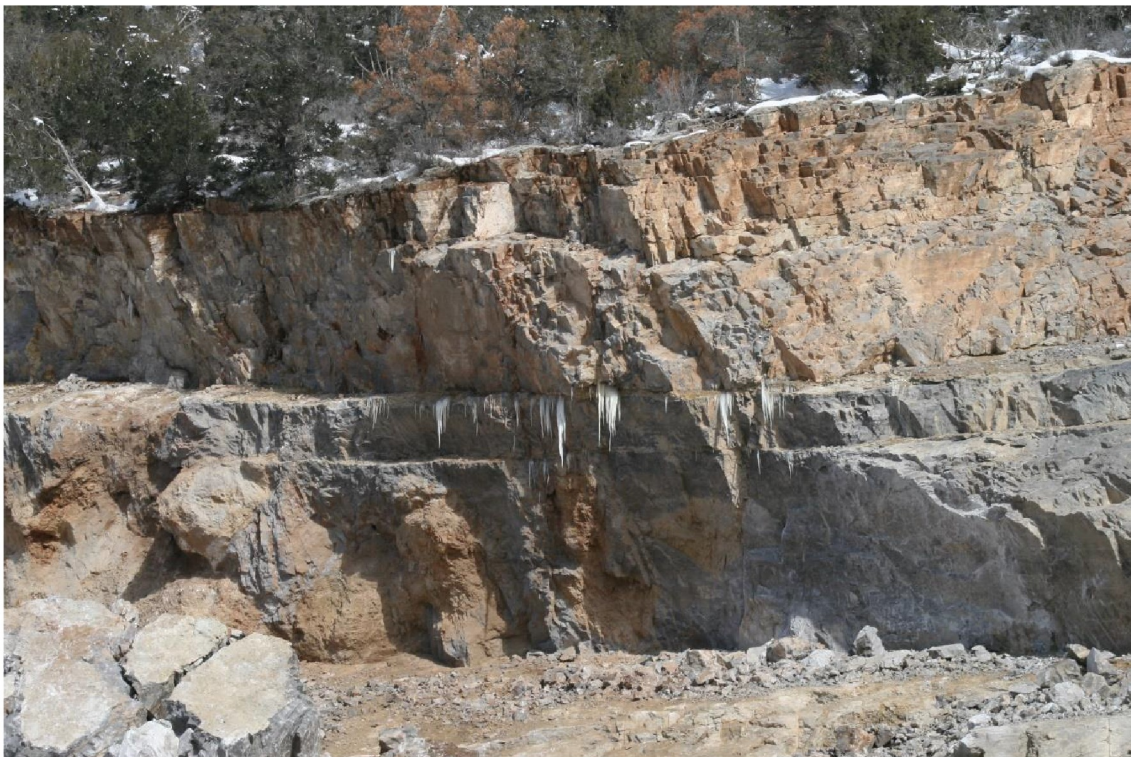
Photo 4: Icicles were formed particularly along the basal contact of the upper limestone bed. (1/26/23 Photo# 0584)

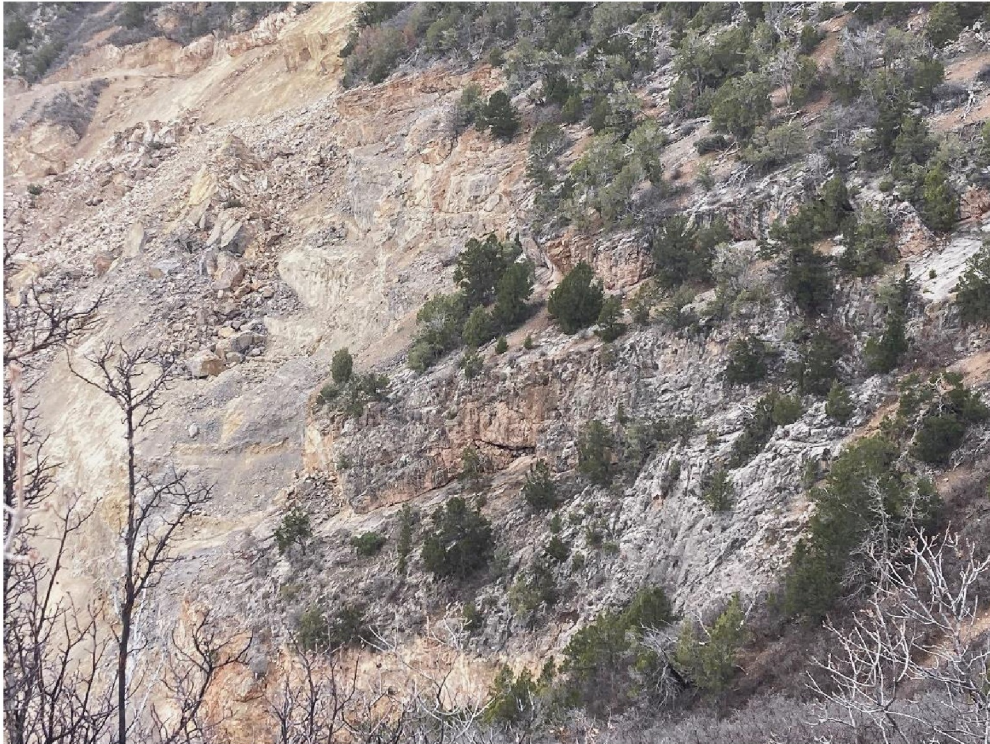
Photo 5: Side view, looking west, of the two upper units of the limestone of the East Face. The West Face ground event can be seen in the background along strike. (4/14/23 Photo# 2014)

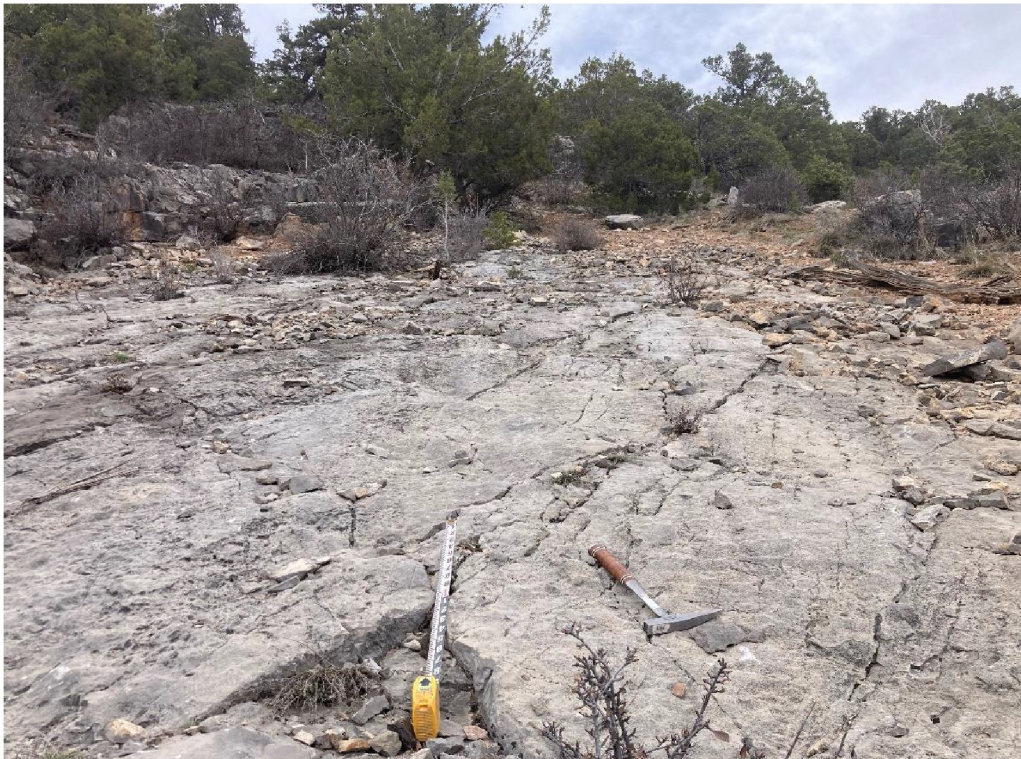
Photo 6: Bedding plane of upper limestone unit exposed within the East drainage. Plane has very high persistence, planar, moderately rough, JRC 10-12. (4/14/23 Photo# 2016)

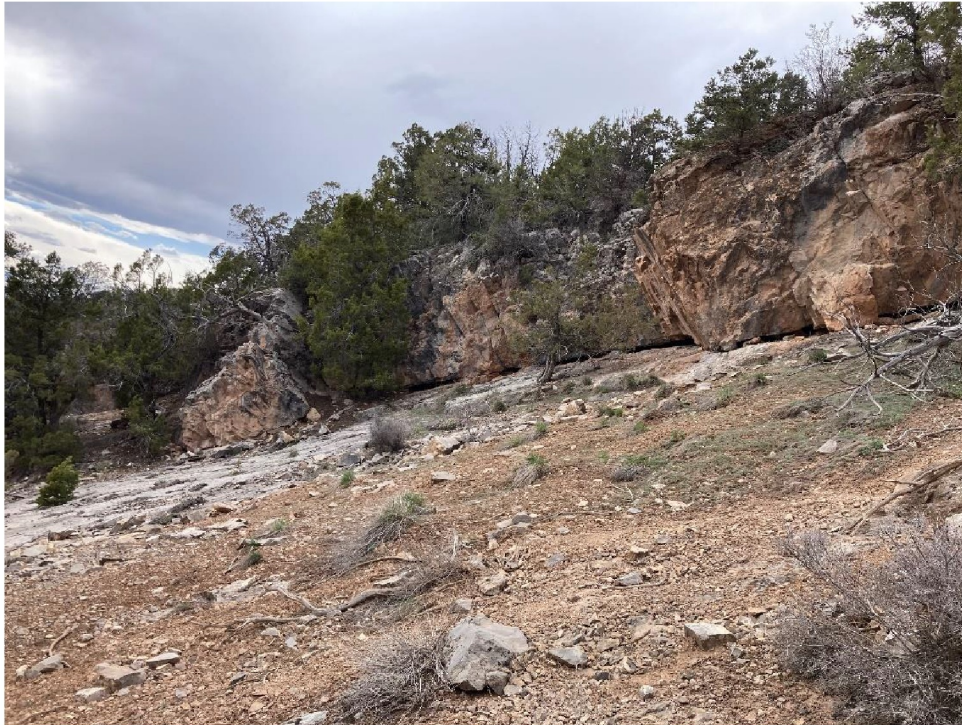
Photo 7: Bedding plane of upper limestone unit on the East face with the secondary joint release plane defining the structure of the outcrop. (4/14/23 Photo# 2023)

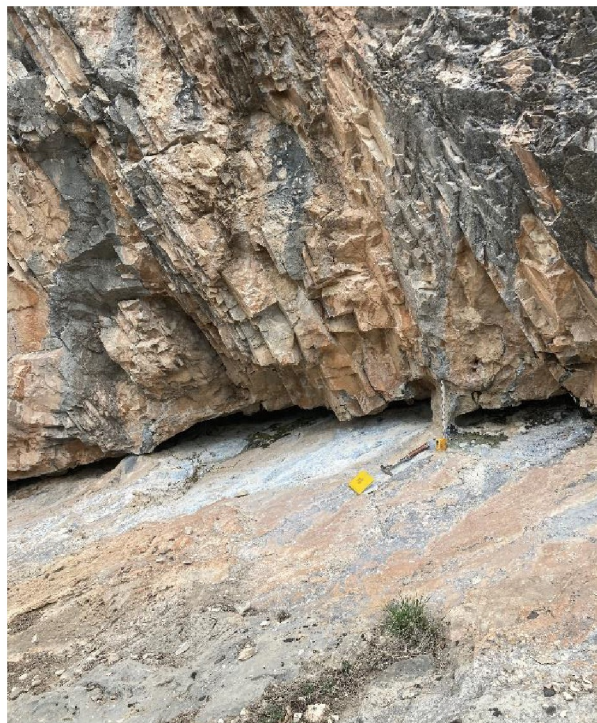
Photo 8: Open aperture of the upper and lower limestone bed where the interbed has been eroded back 3 – 5 feet from the outcrop face. Asperities and direct connections between the two limestone beds creates a rough to very rough surface. (4/14/23 Photo# 2023)

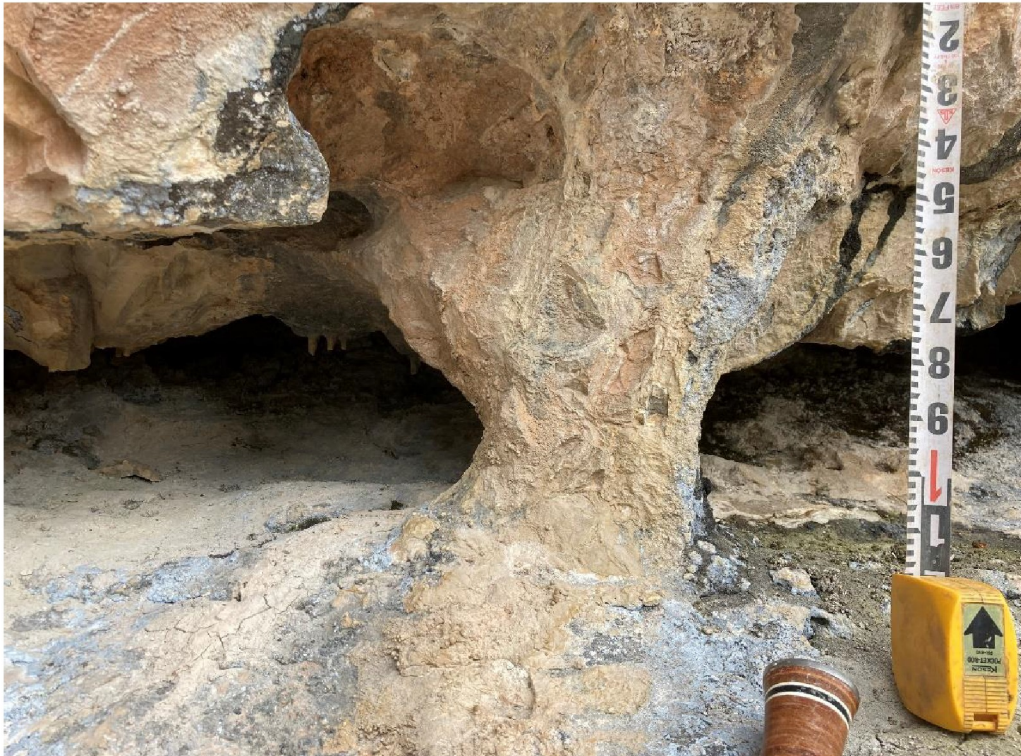
Photo 9: Stalactites formed from CaCO_3 water leeching down the face of the limestone and along the basal contact adhering the two beds together. Other young stalactites can be seen. (4/14/23 Photo# 2023)

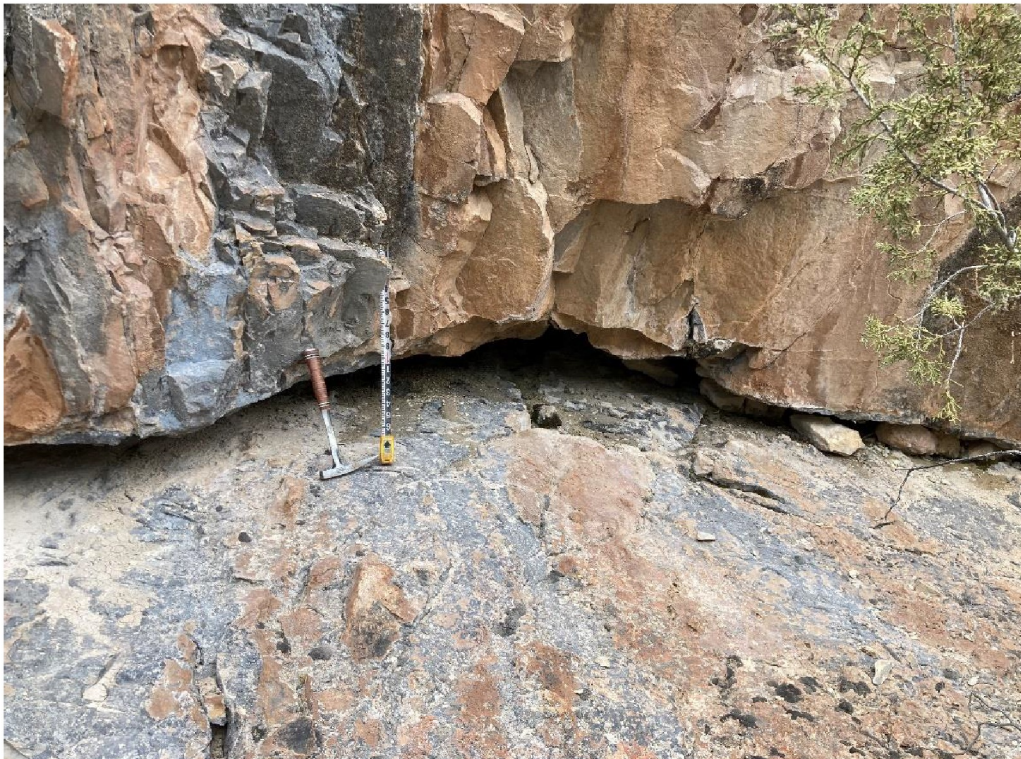
Photo 10: Location of exposed interbed of Photos 11 and 12 eroded back from outcrop face approximately 3 ft (4/14/23 Photo# 2024)

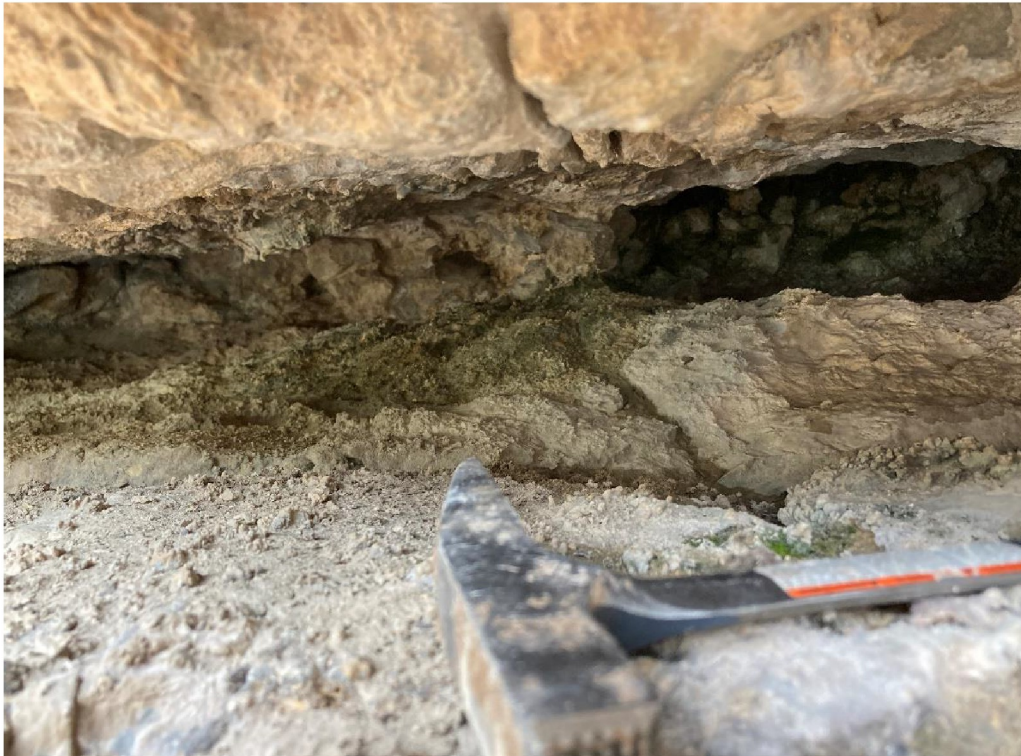
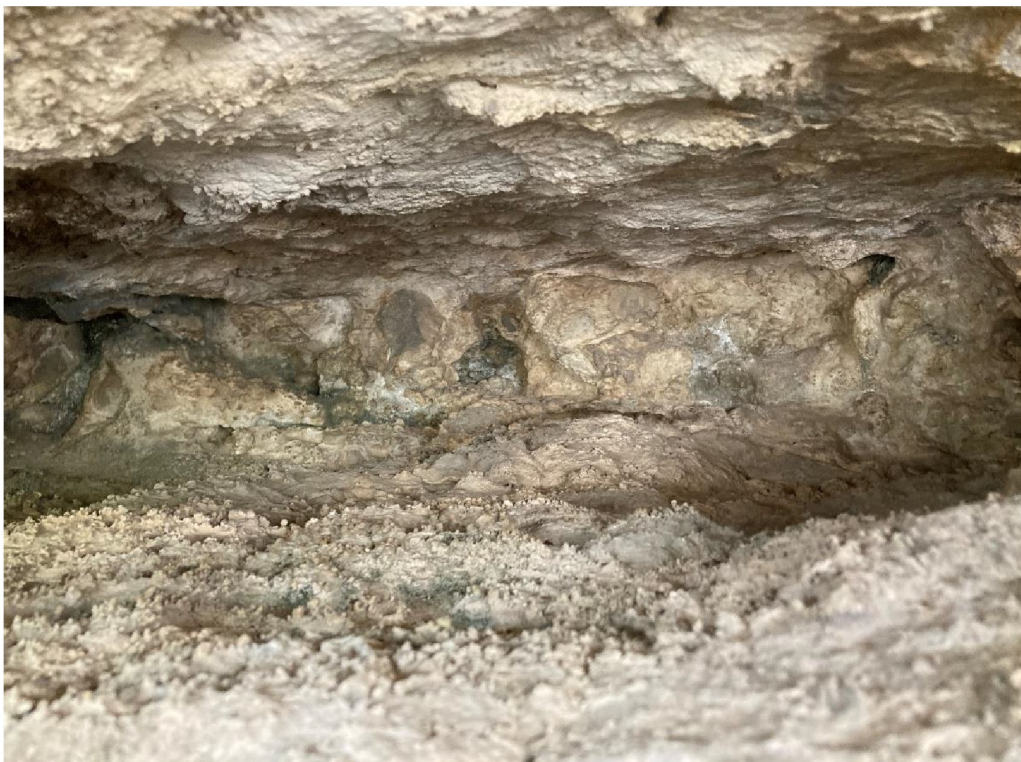
Photo 11 and 12: Interbedded material exposed at the East Face is a weak, cemented mudstone with clasts of limestone.
(4/14/23 Photos# 2028 and 2025)

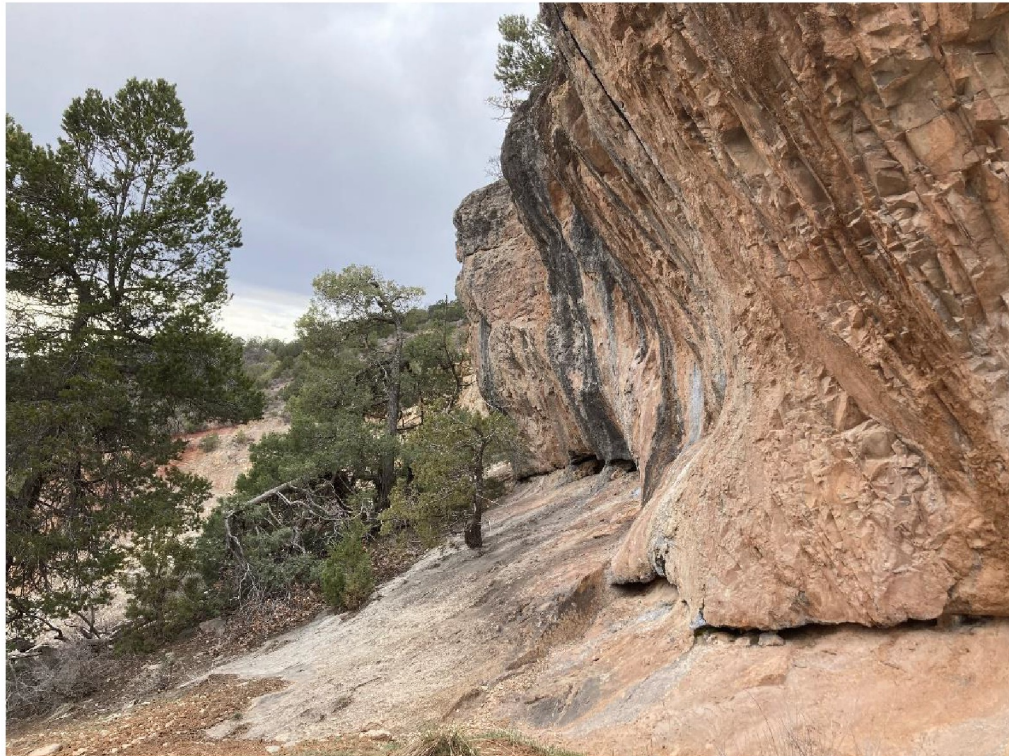
Photo 13: Bedding plane and limestone outcrop on the western extent of the East Face with the West face ground event visible in background along strike. The Bedding plane is undulating and rough with CaCO₃ stalactites and asperities of hard crystals. (4/14/23 Photo# 2032)

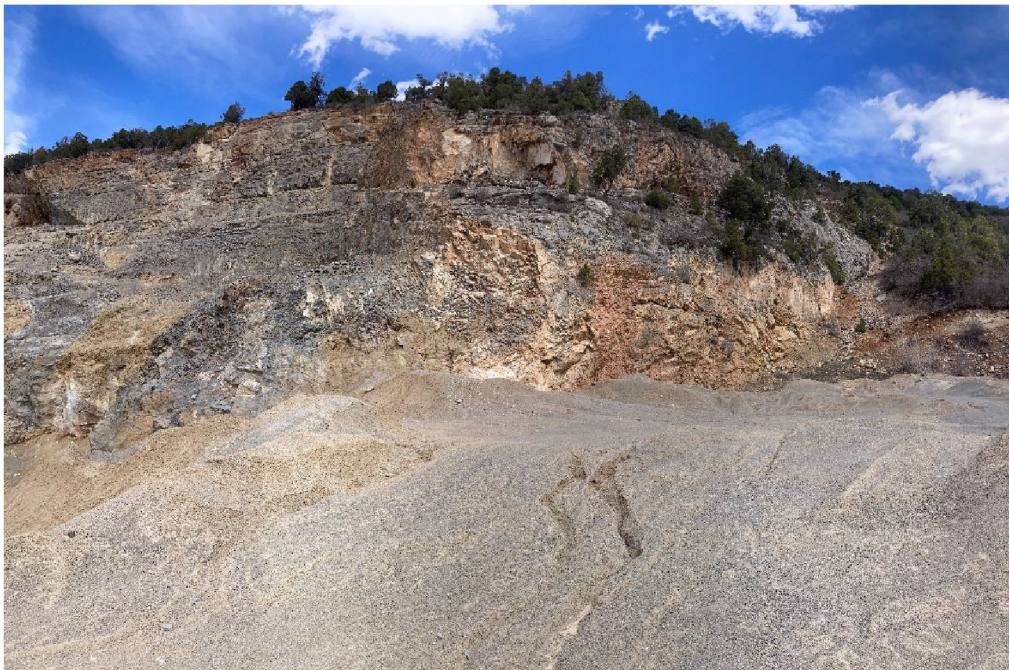
Photo 14: Looking up and north at the East Face. The bedding breaks defining the upper limestone beds are apparent. The East drainage on the right defines the eastern limit of operations. (4/14/23 Photo# 2002)
