## Appendix F

### JULY 2023 WEST FACE FIELD PHOTOGRAPHS

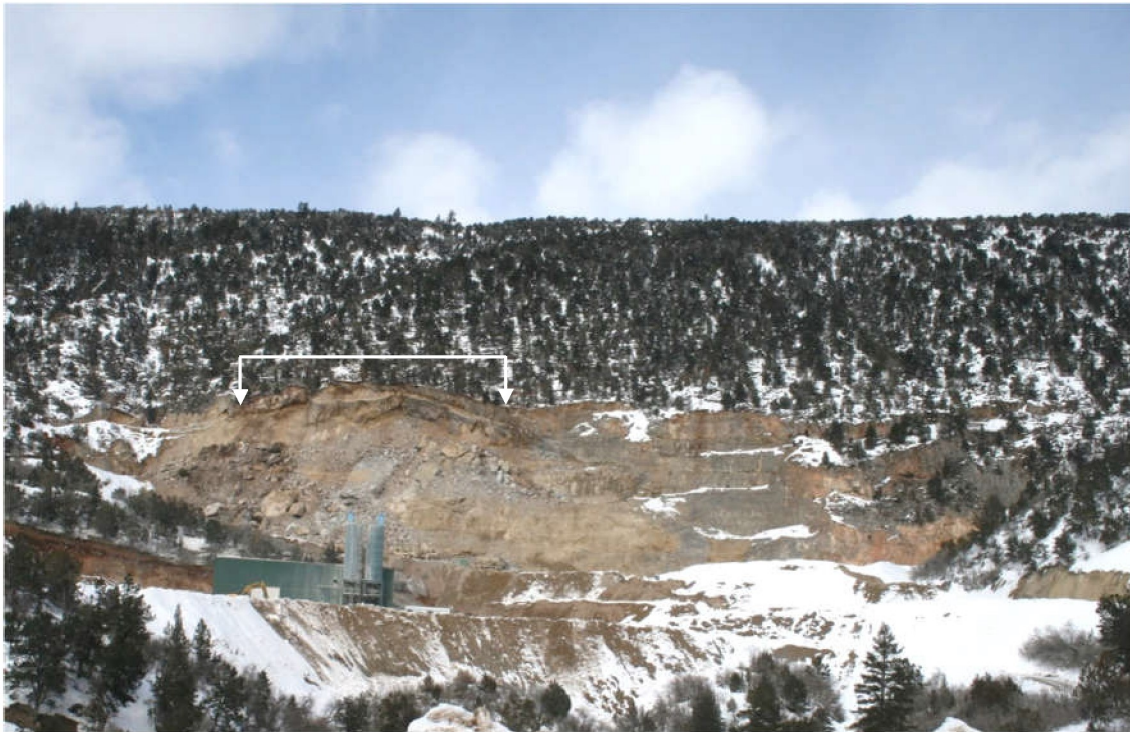
Photo 1: View of the Mid Continent Mine, west face on the left. The January 2023 headwall ground event (extent indicated by white arrows) released on a consistent, NE-dipping joint plane. (1/26/23 Photo# 0613)

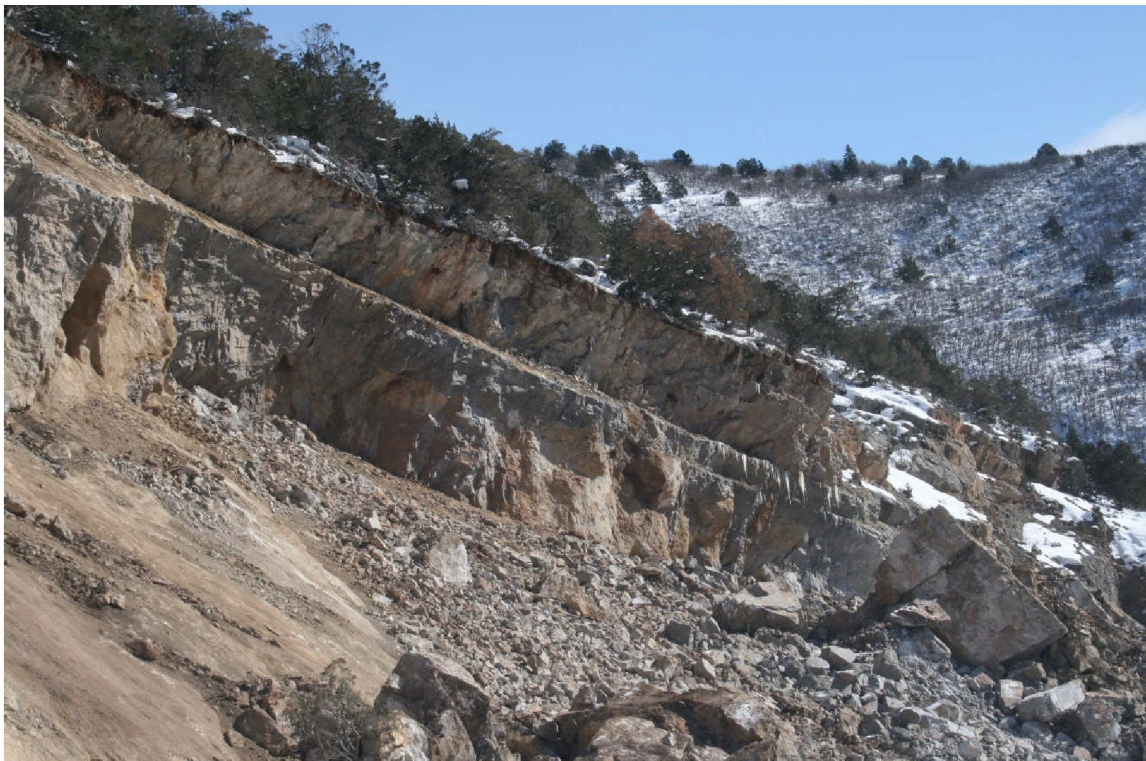
Photo 2: Side view, looking east, of the two upper units of the limestone with bedding acting as the slide plane. The upper limestone units pinch out upslope, to the north (1/26/23 Photo# 0598)

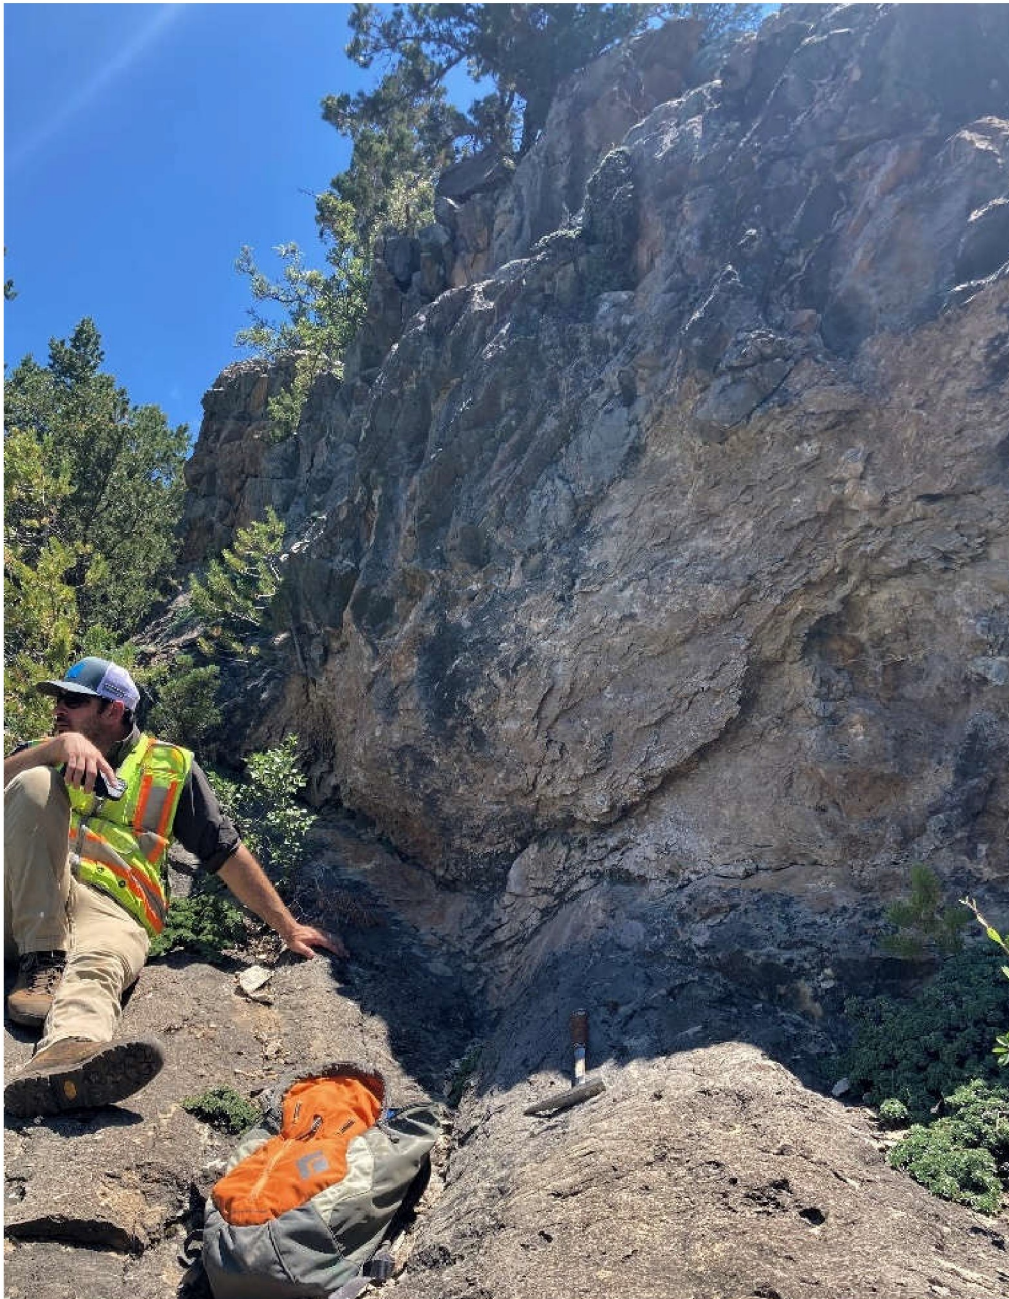
Photo 3: Tape measured 15 ft of upper beds sitting on laterally continuous bed surface, dipping 34°;185. No significant aperture or interbed between the upper and lower limestone. Location on Figure 2. (7/6/23 Photo# 2209)

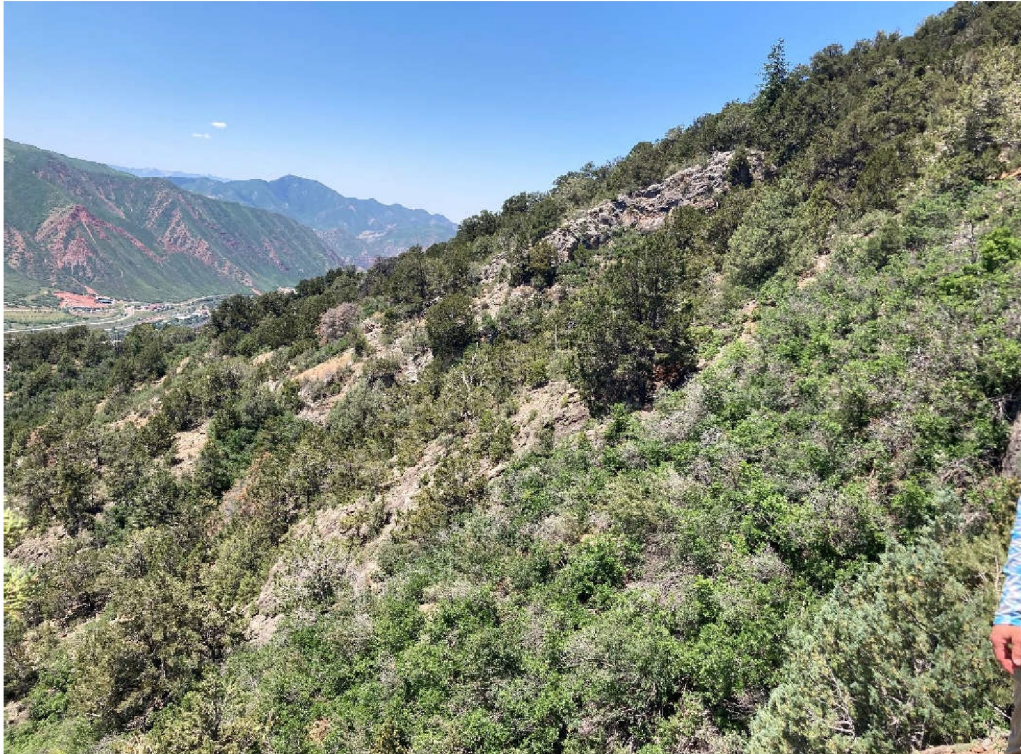
Photo 4: Looking west across drainage, commensurate laterally continuous bed surface exposed. Loss of upper beds at the drainage confluence ridgeline in foreground. (7/6/23 Photo# 2210)

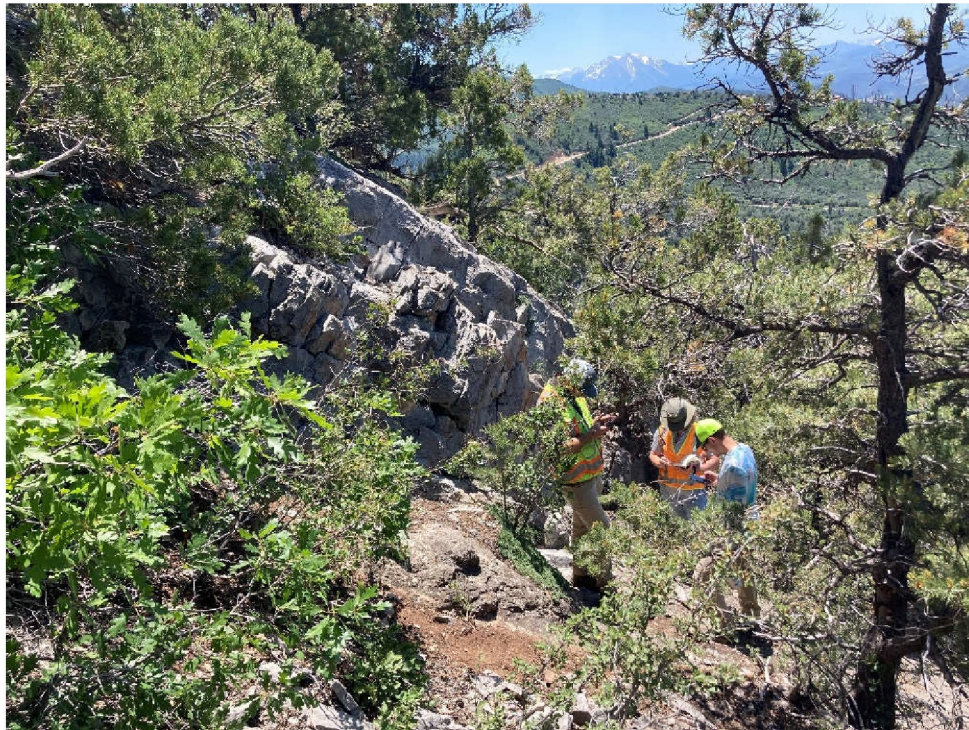
Photo 5: Tape measured 10 ft of lower and upper beds sitting on laterally continuous joint surface. No significant aperture or adverse interbed. Location denoted on Figure 2. (7/6/23 Photo# 2211)

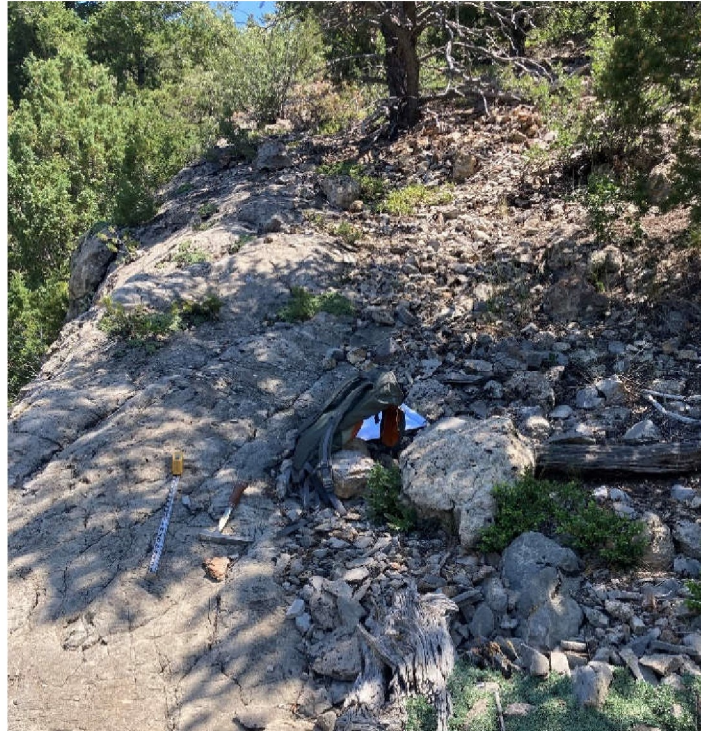
Photo 6: Laterally continuous, wavy bedding plane dipping 28°;183. Location denoted on Figure 2. (7/6/23 Photo# 2206)

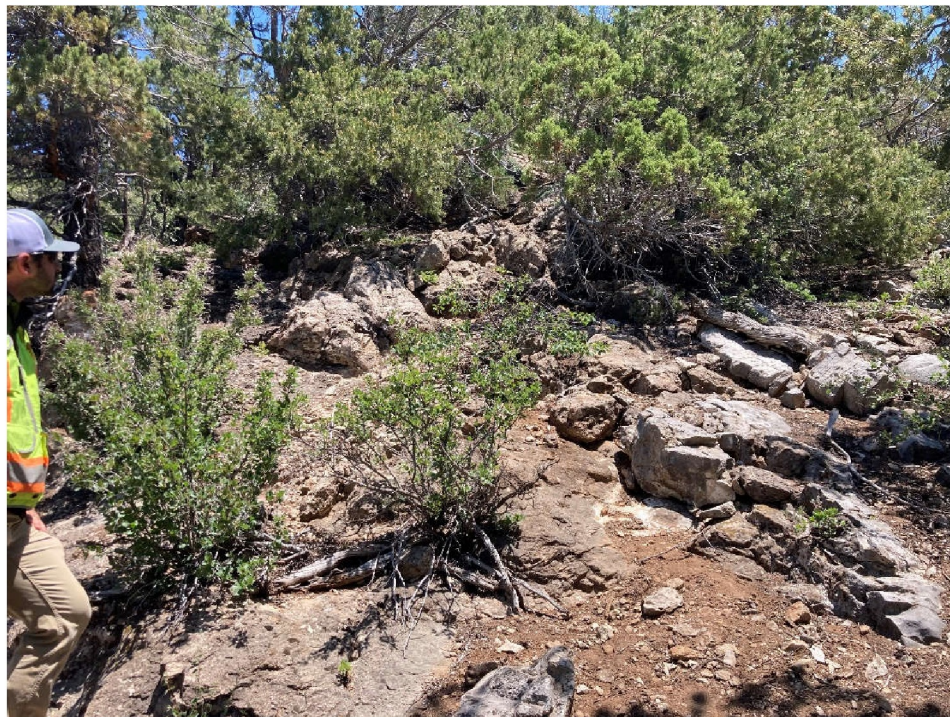
Photo 7: Upper limestone beds have pinched out at this location, denoted on Figure 2. General loss of float from typical upper unit. (7/6/23 Photo# 2212)
